TITLE: Fracture and Residual Characterization of Tungsten Carbide Cobalt Coatings on High Strength Steel

TITLE: International Conference on the Mechanical Behavior of Materials [9th], ICM-9, Held in Geneva, Switzerland on 25-29 May 2003

FRACTURE AND RESIDUAL STRESS CHARACTERIZATION OF TUNGSTEN CARBIDE COBALT COATINGS ON HIGH STRENGTH STEEL

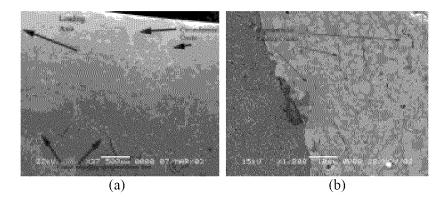
Cracks in WC wt. 17% Co high velocity oxygen fuel (HVOF) thermal spray coatings subjected to axial fatigue stresses initiate at defects in the coating structure at the surface, and propagate along intersplat regions within the coating structure, avoiding the compressively stressed WC particles as shown in Figure 2. The direction of crack propagation is in the radial direction, perpendicular to the axis of loading.

Figure 2. Images showing: (a) the coating surface cracks after fatigue testing and (b) a polished cross-section of the tungsten carbide cobalt coating with interlamellar cracks propagating along phase boundaries around the white carbide particles.

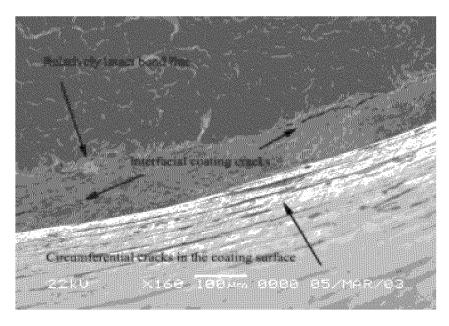
Microscopic examination of cross-sections and fracture surfaces showed that when the deep coating cracks either propagate along the bond-line interface or turn back into the coating and propagate along splat boundaries in the first few layers of deposited coating as shown in Figure 3. High magnification scanning electron microscopy of the fatigue specimens fracture surface clearly showed that the substrate fatigue crack origins were located at either a subsurface inclusion, or at a coating-substrate interfacial bond line defect. The subsurface defects (see Figure 4A) were the predominant mode of initiation at applied fatigue stresses below 150ksi; the longer fatigue life indicates that the properties of the substrate controlled fatigue initiation. Whereas, for the specimens tested above 150ksi maximum applied stresses, substrate-coating interface defects predominated as the substrate fatigue site origin (see Figure 4B). Energy dispersive spectroscopy confirmed that the defects at the coating-substrate interface were imbedded aluminum oxide particles from the grit blasting operation prior to coating deposition. The subsurface defects could not be identified but could be M₂C carbide particles at grain boundaries or sulfur inclusions in the matrix [6].

Figure 3. SEM micrograph showing the coating cracks at the substrate bond-line interface.

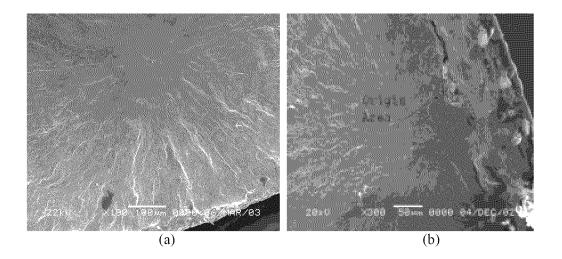
Figure 4. SEM Micrographs showing: (a) subsurface origin in a 4340 specimen tested at 150ksi maximum applied stress, and (b) surface origin at an aluminum oxide particle in a 4340 specimen tested at 220ksi maximum applied stress
